## Appendix J

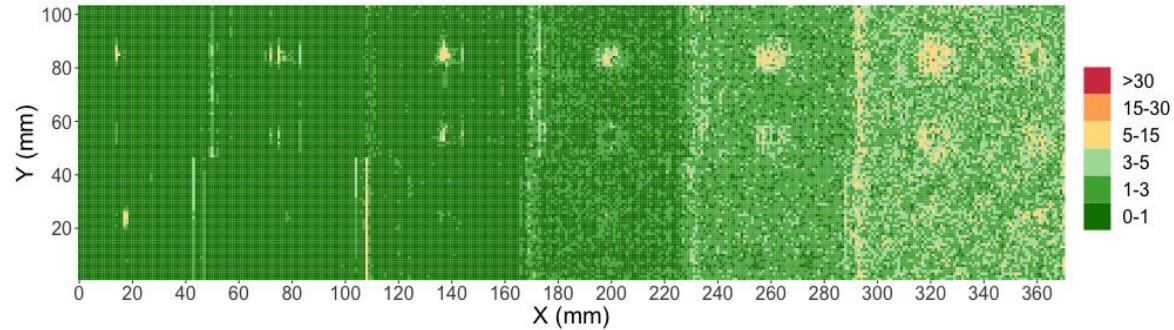
Figure J.1: Heatmap of Cv values (%) for repeated PAUT inspection of M3.

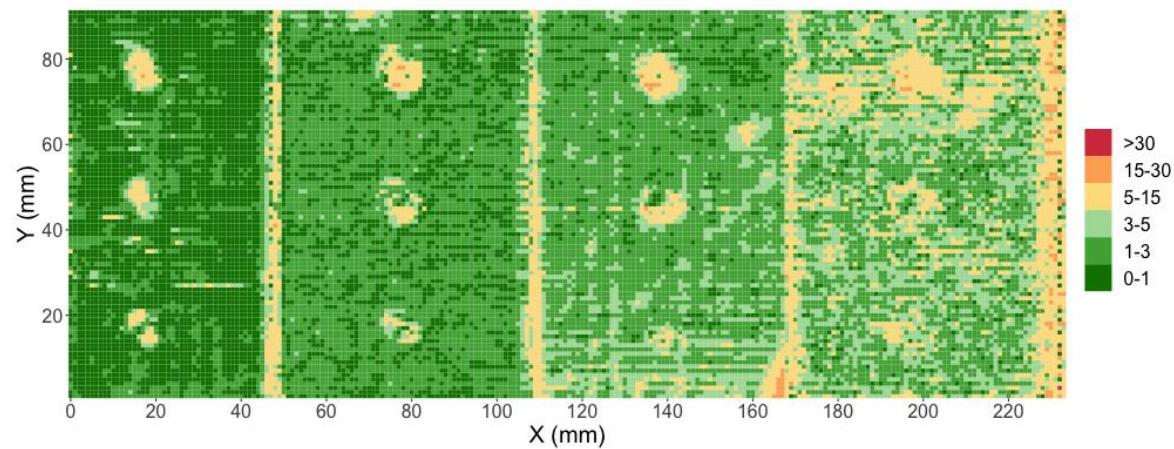
Figure J.2: Heatmap of Cv values (%) for repeated SEUT contact inspection of M3.

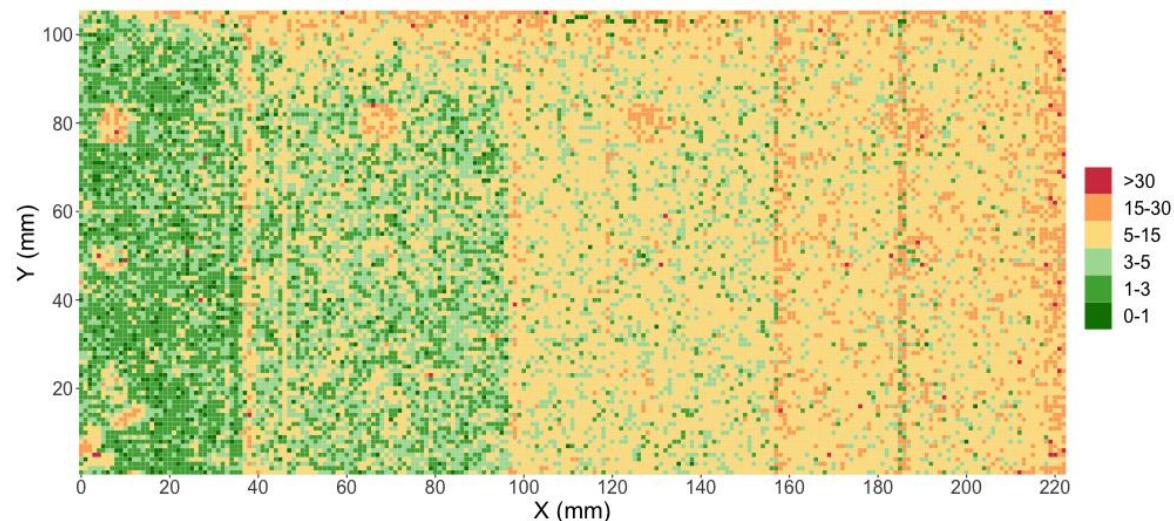
Figure J.3: Heatmap of Cv values (%) for repeated SEUT squirter inspection of M3.
